Particulate Erosion Mechanisms

P. Veerabhadra Rao and Donald H. Buckley
Lewis Research Center
Cleveland, Ohio

Prepared for the
Cavitation and Multiphase Flow Forum
sponsored by the American Society of Mechanical Engineers
New Orleans, Louisiana, February 11-17, 1984

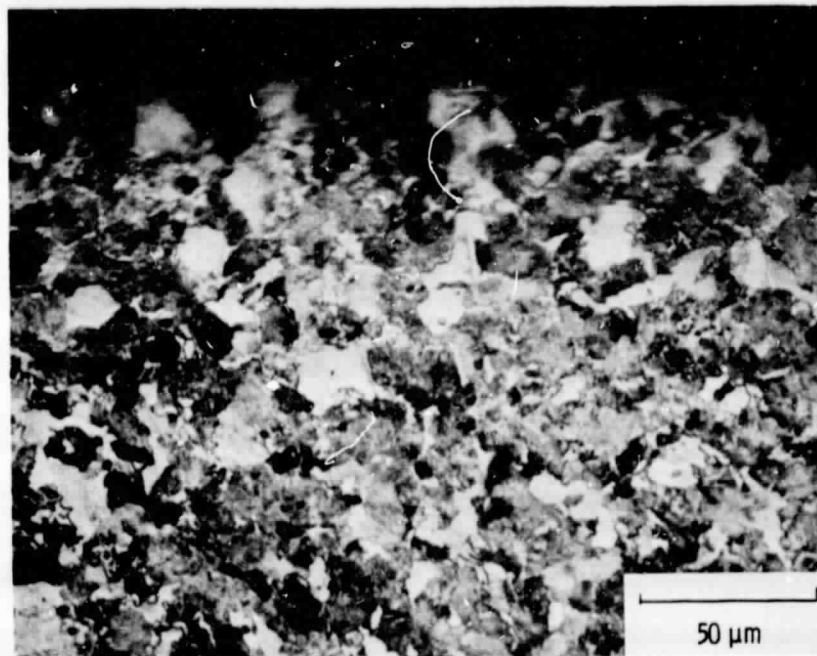
(c) 1045 steel.

Figure 5. - Concluded.

Figure 5 presents cross-sectional views of an aluminum alloy, copper and 1045 steel specimen surfaces after 10 min exposure to 100 m/s velocity glass bead jet impingement. The advanced stages of erosion have been specifically chosen in order to understand some specifics of erosion mechanism at the subsurface which is not seen at the inception stages of damage. In Fig. 5(a), (aluminum alloy), origin of subsurface damage is observed and cracking extends approximately up to 120 μ m deep. Cracking appears not to occur in any preferential direction in a majority of cases. This mechanism may be anticipated due to the maximum shear stress occurring at subsurface during impingement. The initiated crack beneath the surface radiates to the surface or joins with the adjacent cracks to remove material. In light of high-stress incident on the surface, this type of subsurface cracking and surface fatigue damage are anticipated. In this particular case, the "delamination theory" proposed by Suh [8] and "shear localization theory" proposed by Shewmon [6] appear to be significant. It is rather strange that Figs. 5(b) (copper) and 5(c) (1045 steel) do not show any subsurface damage. One may anticipate at this juncture that copper and 1045 steel may still require higher particle sizes and velocities in order to cause observed subsurface damage. Further, photographic observations indicate that surface cracks initiate at grain boundaries for copper which is not a general damage feature.
